UNIVERSITY OF MINNESOTA
ST. ANTHONY FALLS LABORATORY
Engineering, Environmental and Geophysical Fluid Dynamics

PROJECT REPORT 476

Hydraulic Model Study of the Stilling Basin with a Baffled Chute

Prepared for
MWH Americas, Inc.
Denver, Colorado

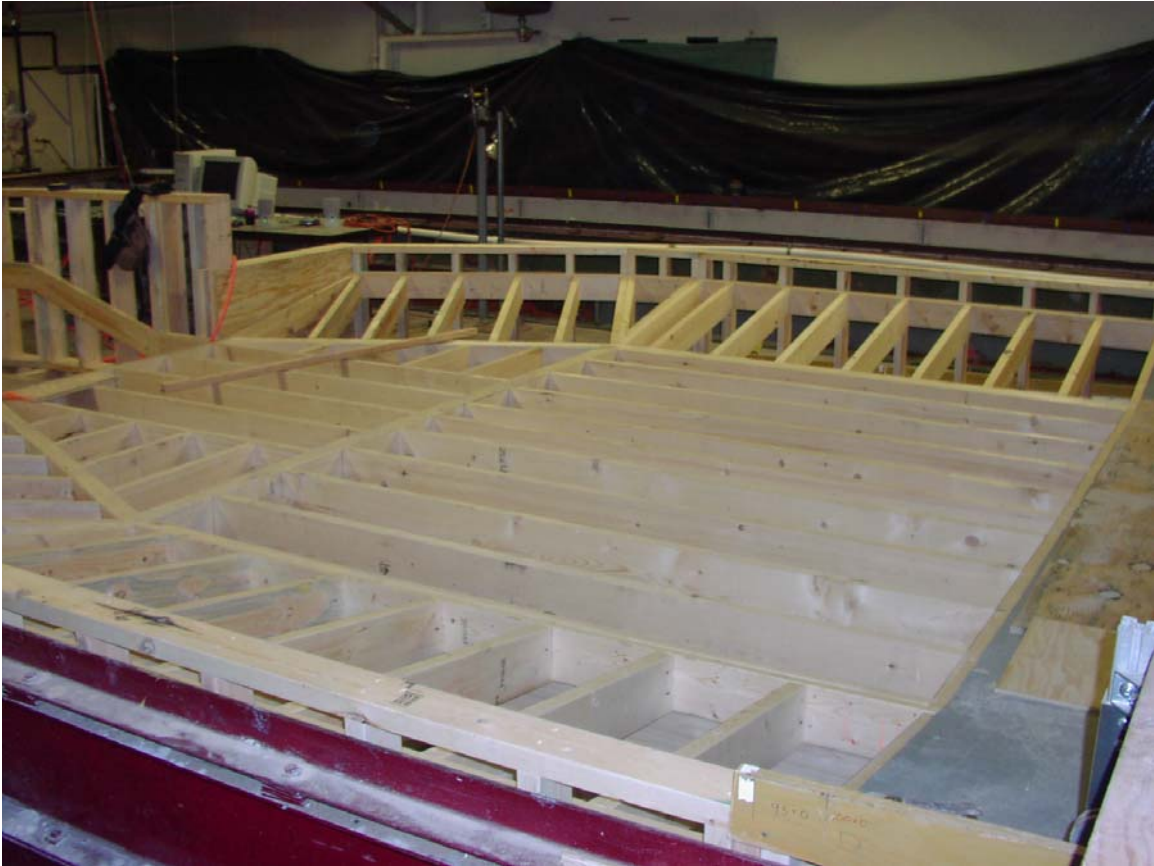
Figure 2.2. Modifications made to the downstream channel using lumber.

The new design proposed by MWH is shown in Figure 2.1. The upstream end of the original model, i.e. the reservoir, the gated ogee spillway and part of the chute with a slope of 22:1, and the downstream end of the model, i.e. a section of the tailrace channel and the leaf drop gate for controlling the tailwater condition, were maintained as in the original model (Mohseni et al., 2005). In the new design, most of the chute downstream of the ogee spillway and the stilling basin were modified. All modifications were built from plywood and lumber (Figure 2.2 and 2.3), painted and sealed.

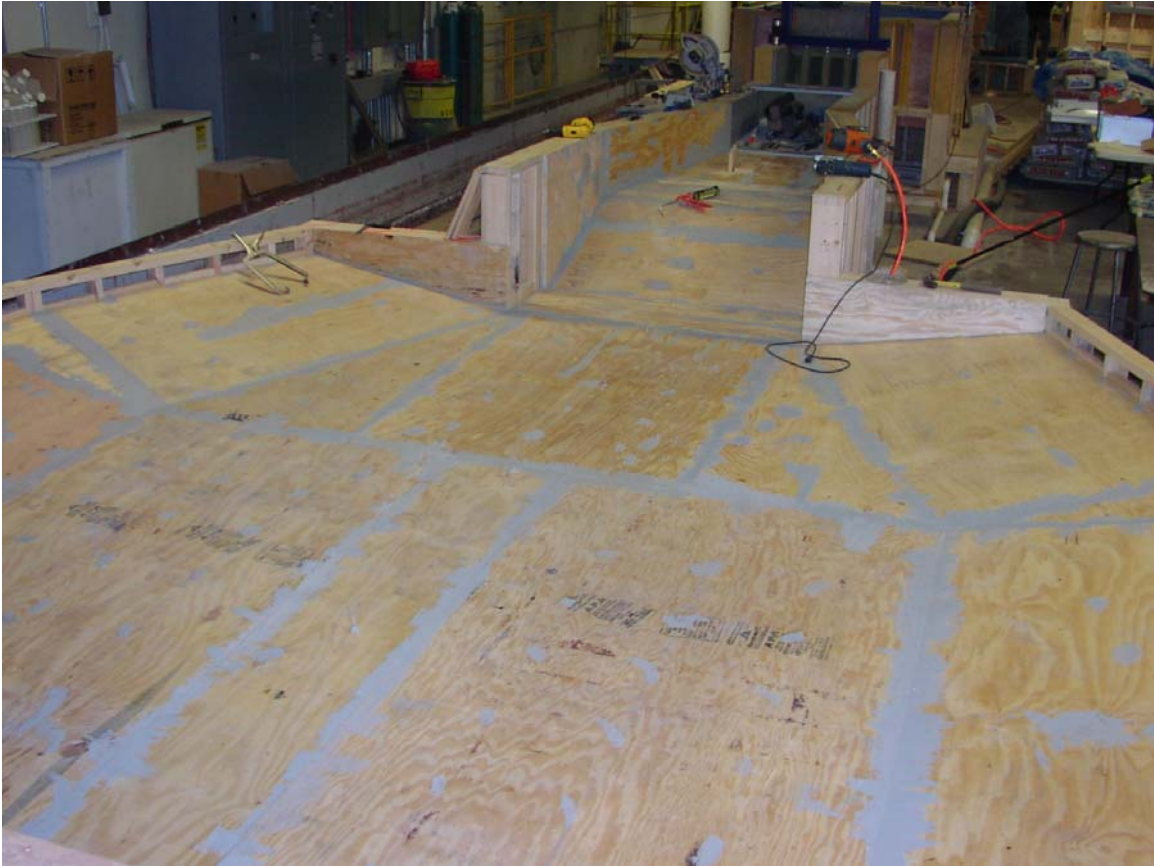
Figure 2.3. The model was built from lumber and plywood and sealed.

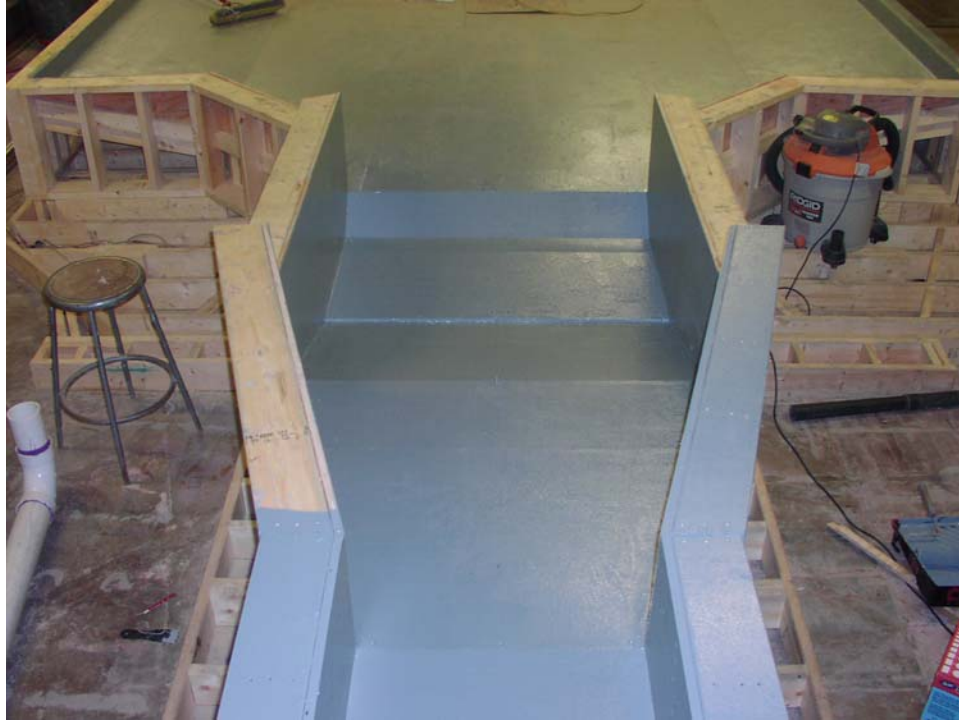
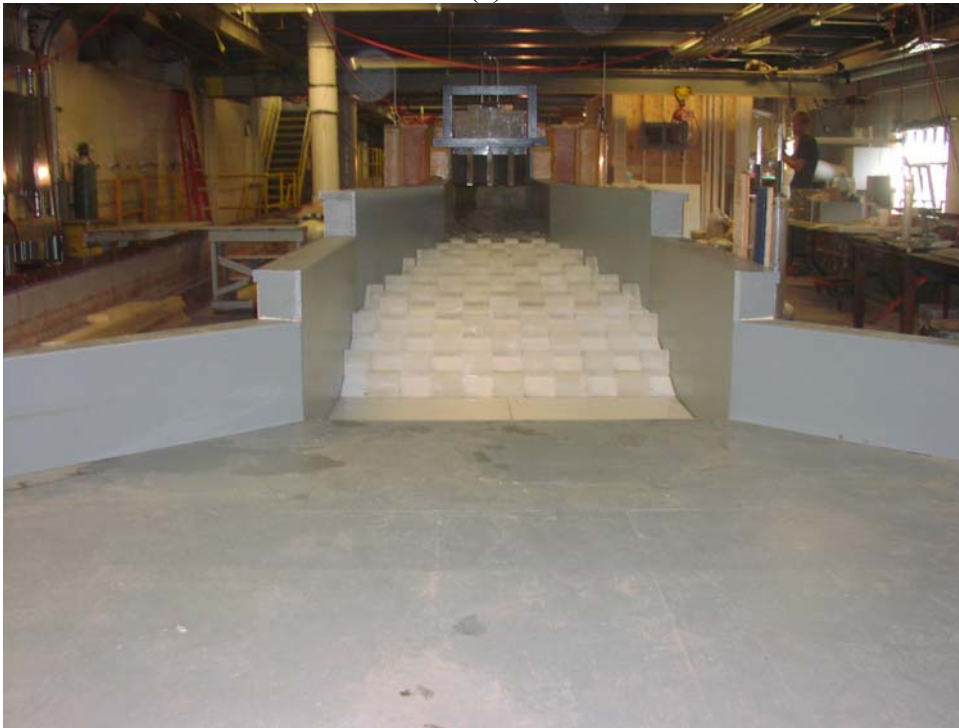
(a)

(b)

Figure 3.19. Photos of the final design of the stilling basin (a) looking downstream prior to the installation of the baffle blocks, and (b) looking upstream after the installation of the baffle blocks. The white boards underneath of the blocks and inside the stilling basin were removable.

The model layout is shown in Figure 3.18 and the constructed model is shown in Figures 19a and 19b. The model chute was built such that the mid size and large baffle blocks could be reconfigured. In addition, provisions were made to easily lower the bed elevation of the model stilling basin by one ft (the white board shown in Figure 19b), i.e. providing a bed elevation of 0.5 ft above the datum. With the bed elevation at 0.5 ft, the model stilling basin would become slightly shorter.

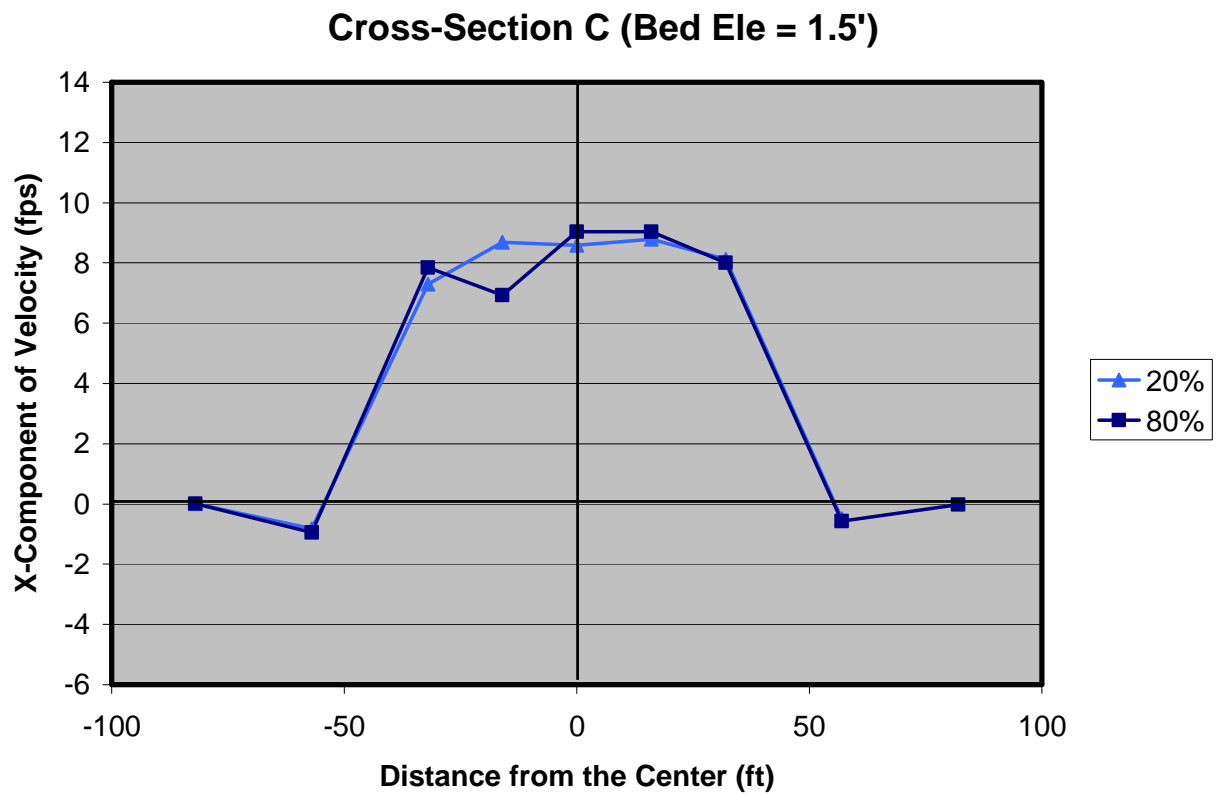
Figure 3.30. X-component of velocity distribution measured at cross-section C under a flow condition of 2271 cfs and a tailwater level of 11.5 ft above the datum. The stilling basin elevation was at 1.5 ft above the datum.

The velocities were measured at the cross-sections and locations shown in Figure 3.21. The water surface profile resulting from this test is shown in Figure 3.27 and the X-components of velocities are shown in Figures 3.28 to 3.32. The velocity distributions across the width were relatively uniform and symmetrical. A very weak flow separation¹ was evident near the wingwalls with very small Y-components of velocity recorded at cross-sections A and B (Figures 3.33 and 3.34). A stronger flow separation was evident downstream of the wingwalls due to the sudden expansion of the cross-section. The maximum X-component of velocity at cross-section A was approximately 10 fps which decreased to 9 fps at cross-section E. The area integrated average velocity at cross-sections A and E were estimated to be 8.7 and 5.2 fps, respectively.

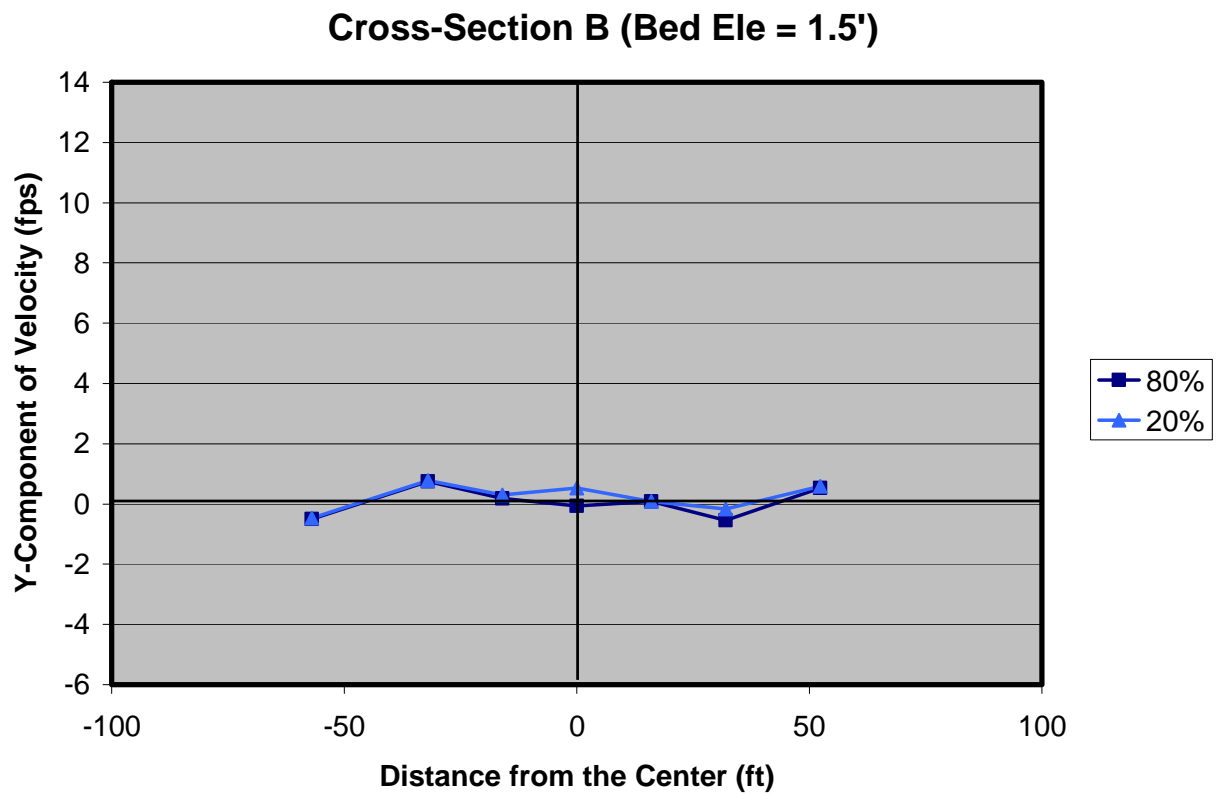
Figure 3.34. Y-component of velocity distribution measured at cross-section B under a flow condition of 2271 cfs and a tailwater level of 11.5 ft above the datum. The stilling basin elevation was at 1.5 ft above the datum.

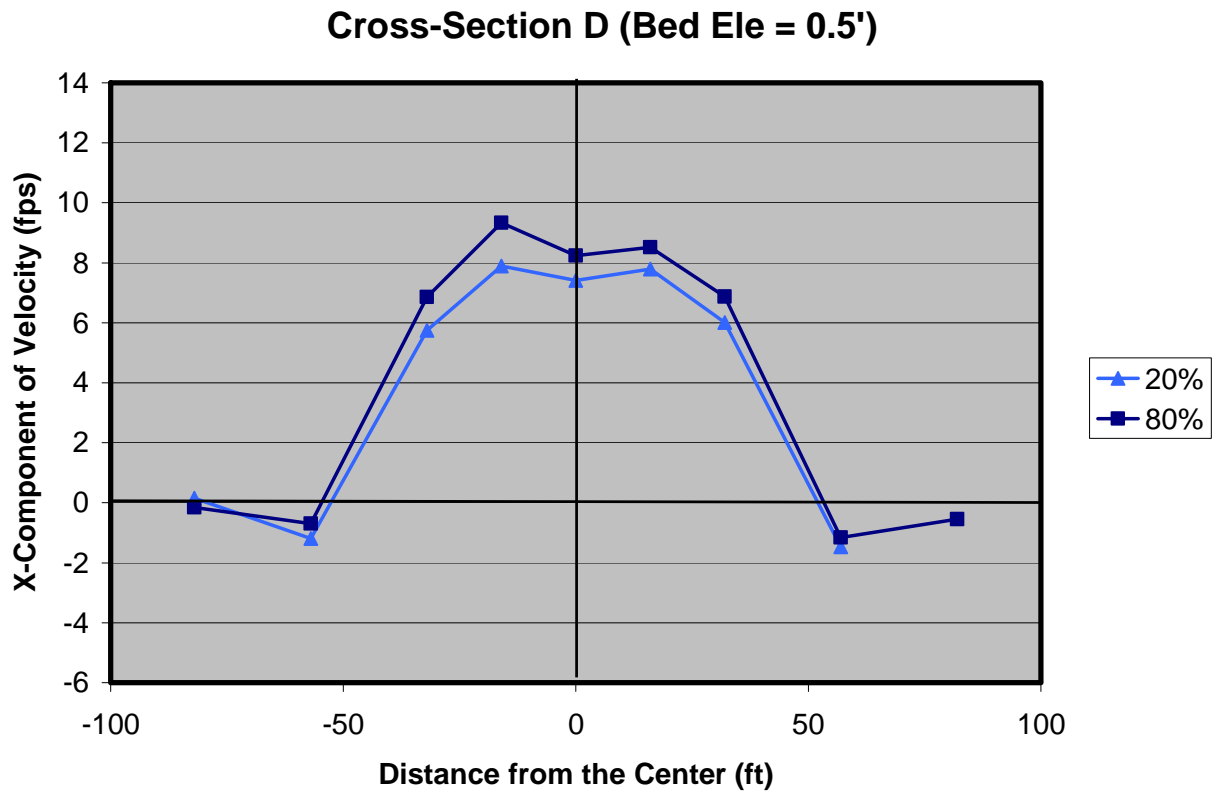
Figure 3.39. X-component of velocity distribution measured at cross-section D under a flow condition of 2285 cfs and a tailwater level of 11.5 ft above the datum. The stilling basin elevation was at 0.5 ft above the datum.

The water surface profile resulting from this test is shown in Figure 3.35 which was similar to the test done with the stilling basin bed elevation at 1.5 ft. The X-components of velocities are shown in Figures 3.36 to 3.40. The velocity distributions across the width were relatively similar to the previous test. Similarly, a very weak flow separation was evident near the wingwalls with small Y-components of velocity recorded at cross-sections B (Figures 3.41) and a stronger flow separation was evident downstream of the wingwalls. The Y-component of velocity at cross-section E is shown in Figure 3.42. The maximum X-component of velocity at cross-section A was approximately 10 fps which decreased to 9 fps at cross-section E.
